HIGHWAY ACCIDENT REPORT

INTERSTATE BUS--AUTOMOBILE COLLISION

INTERSTATE ROUTE 15

Baker, California

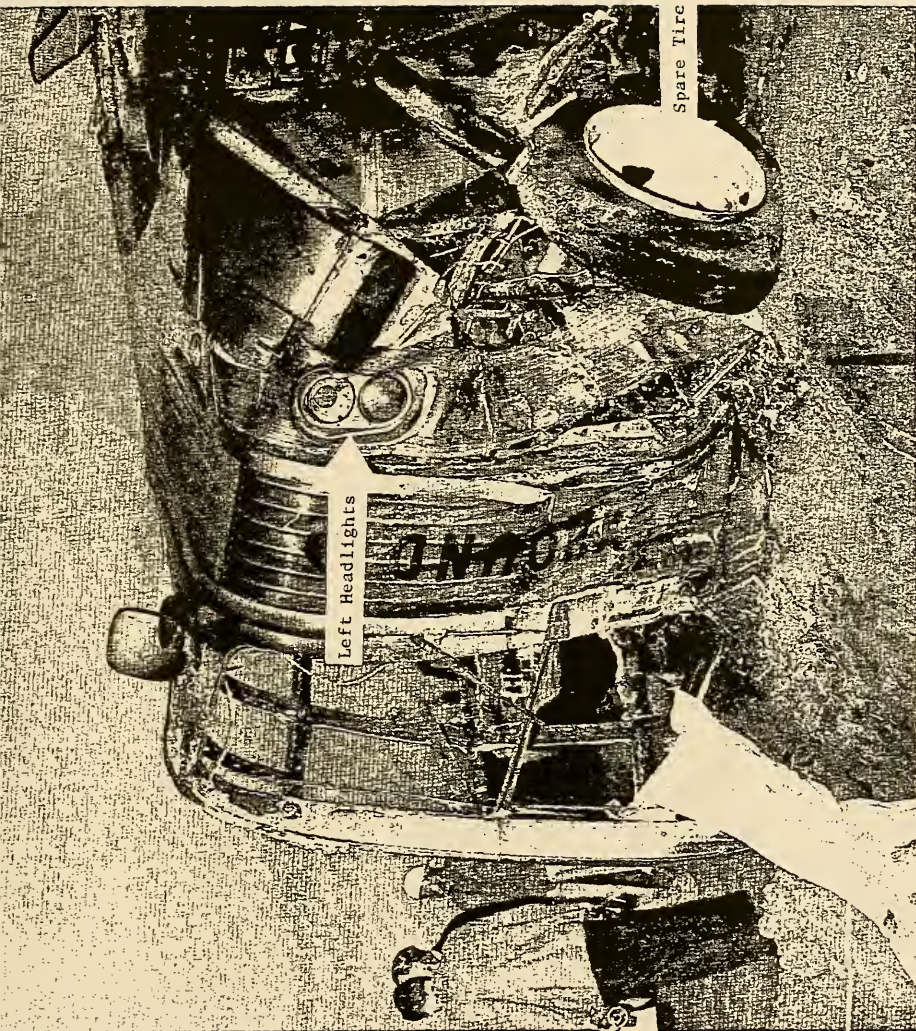
ILLUSTRATION 1

The bus and automobile collided head-on as indicated by damage to the front of the bus from its left headlights through the right front corner (Illustration 1), and to the frontal area of the automobile.

The front of the bus was severely damaged by the impact in increasing severity from the left through its right front corner, primarily in the area below its windshield. The right front wheel assembly, including suspension members, was pushed rearward through a bulkhead, penetrating and compressing the fuel tank (located immediately to the rear of the right front wheel well), and contributing to damage and distortion of the plywood floor of the passenger compartment. The fuel tank contained approximately 115 gallons of diesel fuel. The battery compartment, which was located immediately to the rear of the fuel tank, was also partially crushed and displaced. Both sections of the windshield were ejected from their mountings upon impact. The overturning motion of the bus did not contribute materially to further mechanical damage to the bus. The seats were not dislodged from their floor anchorages as a result of the collision.

Damage to front of bus from left headlights through right front corner.

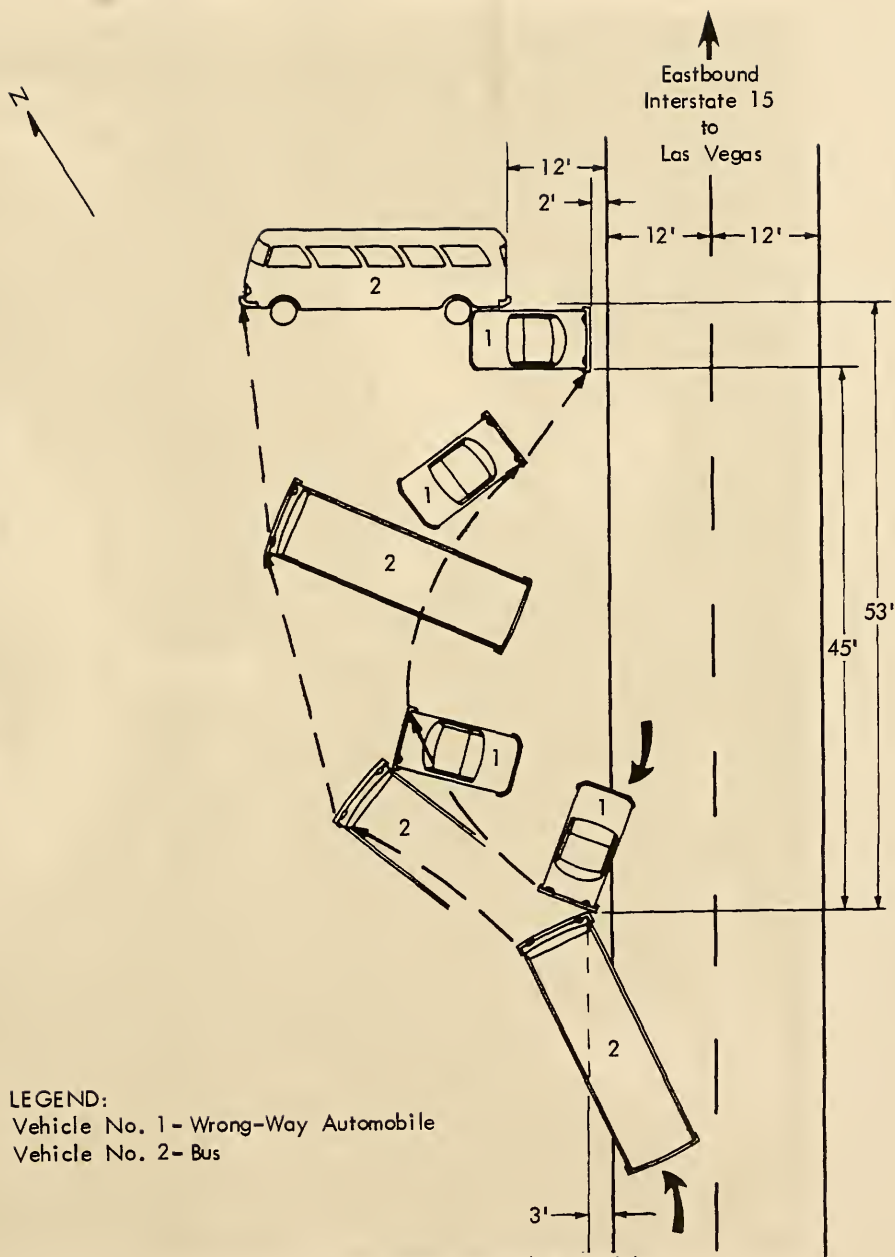
ILLUSTRATION 2 (No Scale)

As the bus was turning, the automobile, after being driven backward 47 feet, traveled momentarily along the right side of the bus, reducing the turning motion of the rear of the bus, while the top portion was unrestrained, resulting in the bus tipping to the right. This tipping action, combined with the loss of stability resulting from the right front wheel being driven backward, caused the bus to turn over 90° onto its right side.

Accident diagram showing relative vehicle position during collision and post-collision phases of accident.

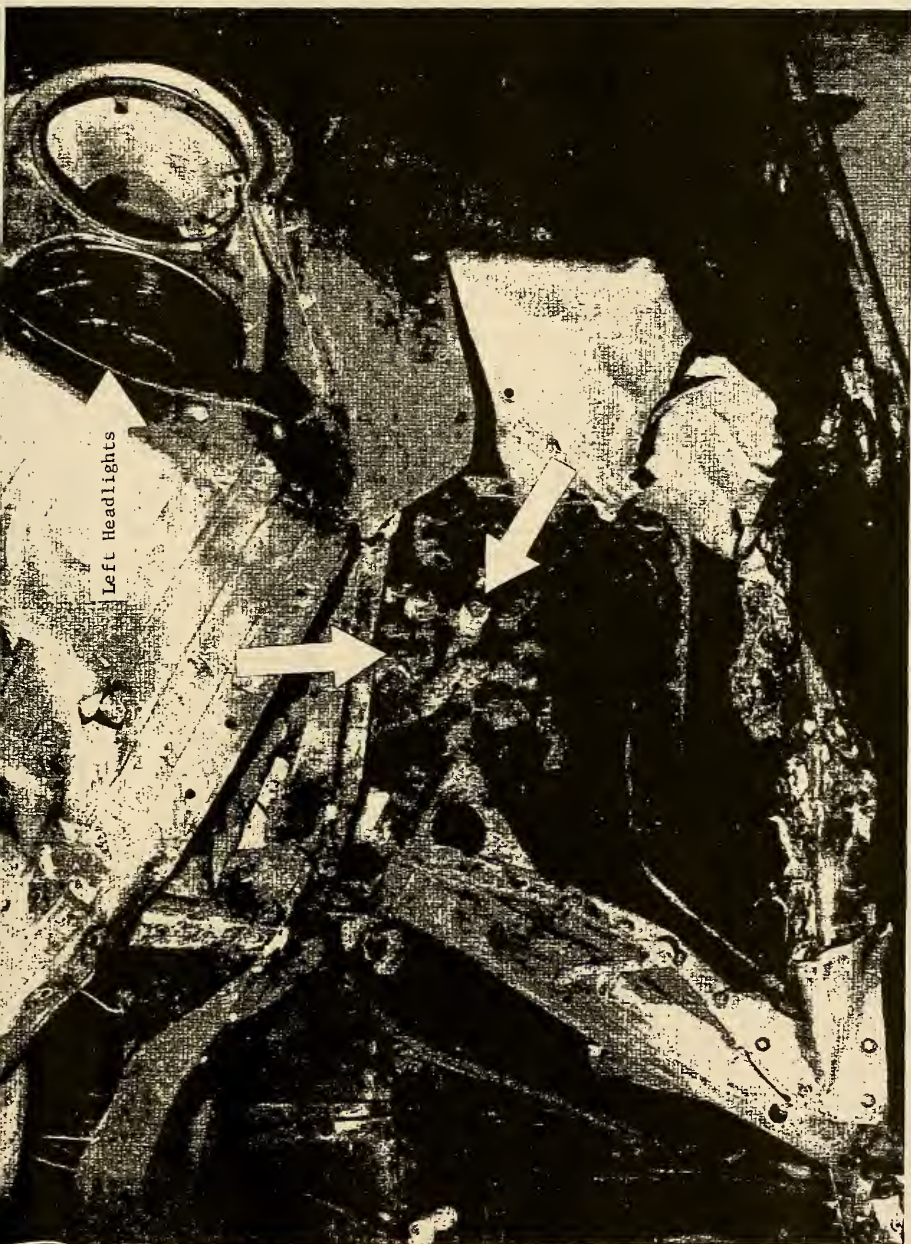
ILLUSTRATION 3

During the collision phase, fire immediately broke out in the front area of the bus, fueled initially by vaporized power-steering oil, and shortly thereafter by diesel fuel. The power-steering oil was discharged from a fitting at the base of the bus steering column which was broken in the collision. (See Illustration 3.) The diesel fuel was sprayed, splashed, and spilled over a large area of the bus, including the baggage and passenger compartments. The fire spread and grew rapidly in intensity.

Fire started in the bus almost immediately upon impact. The fuel source of the initial fire was power-steering fluid under high pressure discharged in a fine mist from a broken fitting at the base of the steering column on the bus. The fluid, #10 lubricating oil, has a flash point of approximately 400° F. when vapors are generated. Due to high torque on the steering, there were probably more than 500 pounds of pressure per square inch generated in the power-steering system at the moment of impact. Such high pressure would cause discharge of the fluid as a fine mist which is highly flammable.

3. The Fire was caused by power-steering oil being discharged under high pressure from a broken fitting damaged by the collision, and

Power steering fluid fitting. Arrows point to severed power steering fluid line.

2. The Safety Board recommends that the Federal Highway Administration, in its development of motor vehicle safety performance standards, review all motor vehicle fuel systems, including diesel fuel; and power steering, and brake systems. Also, in the establishment of crash barrier criteria, full consideration should be given to intrusion factors and flammability of fuels and fluids used in these systems.

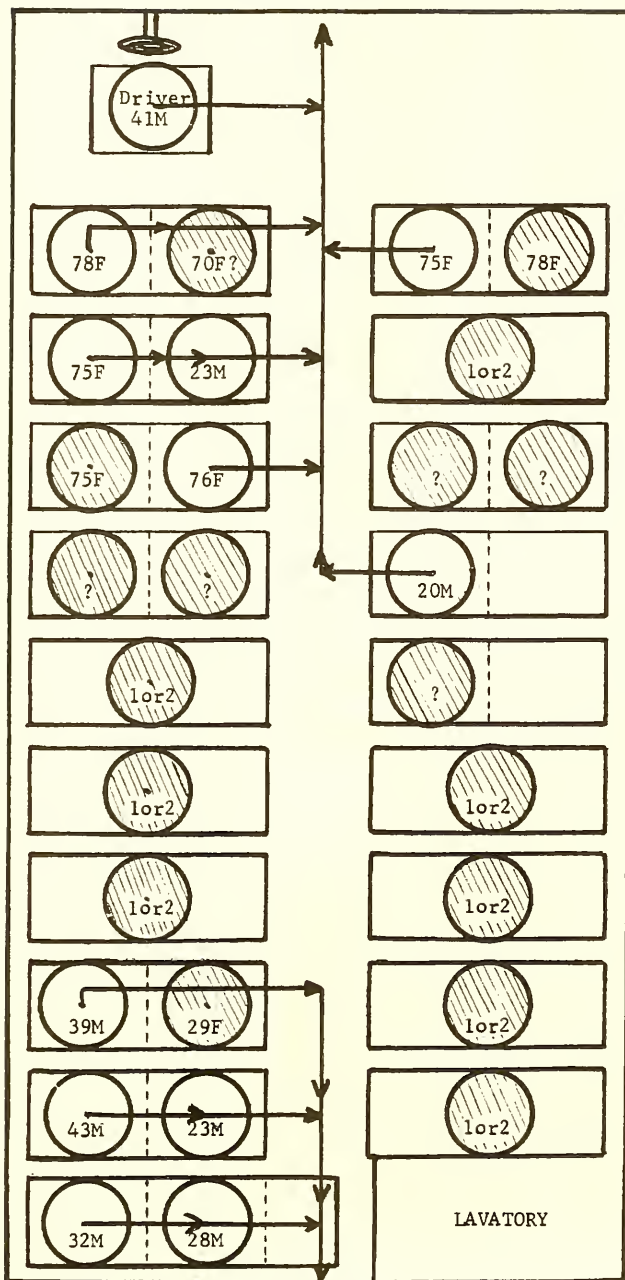
KNOWN AND DEDUCED
SEATING LOCATIONS,
AGES AND SEX OF
BUS OCCUPANTS

←
The Arrow indicates
the escape route of
the survivors.

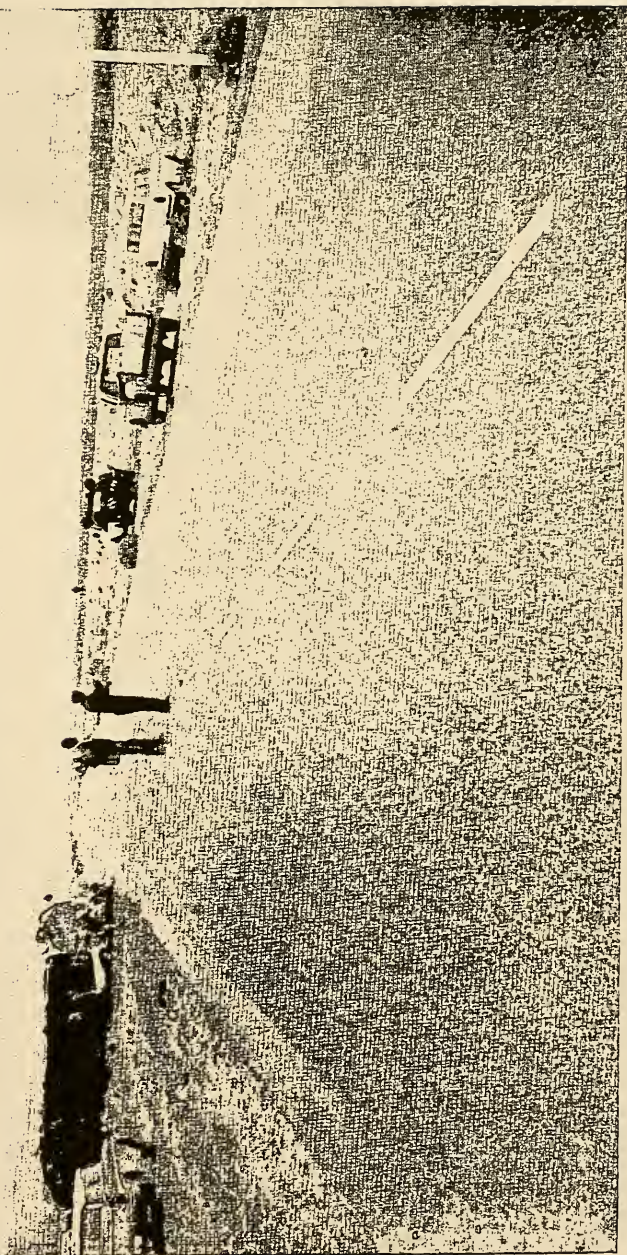
ILLUSTRATION 5

Interstate 15 looking east from accident site. Visibility is without practical limitations

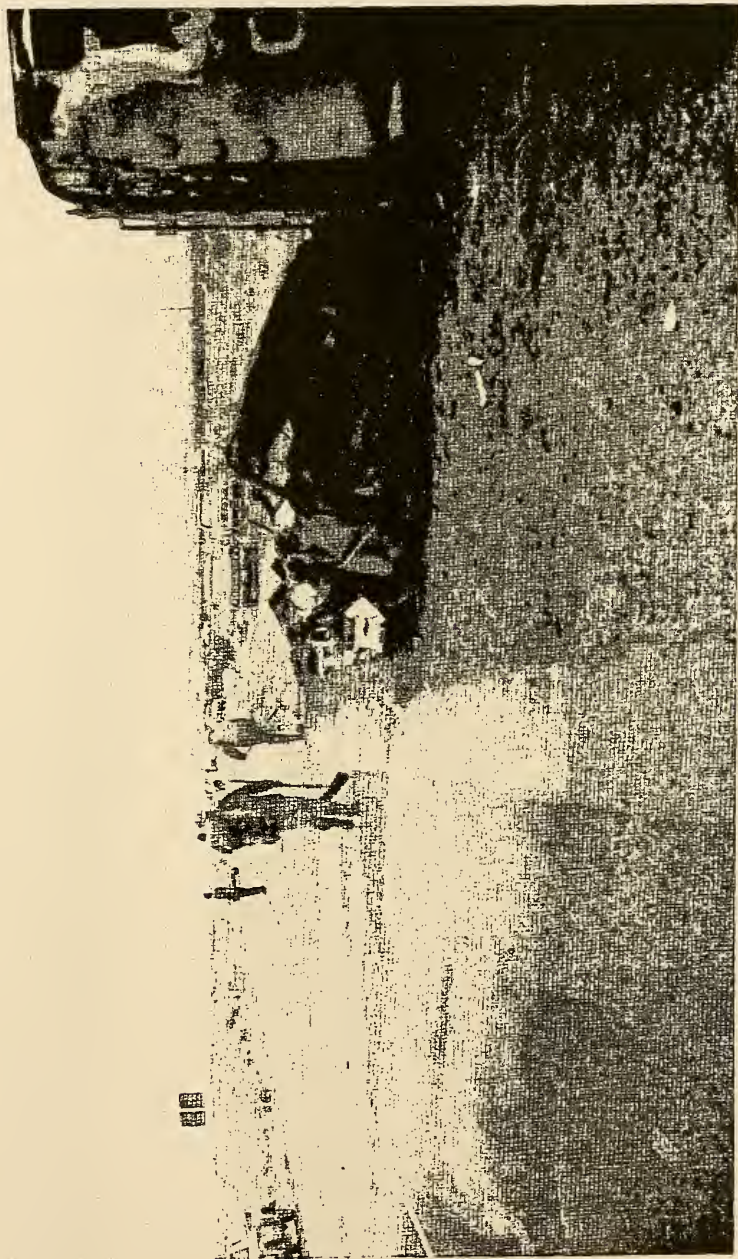
ILLUSTRATION 6

Interstate 15 looking west from accident site. Visibility is without practical limitations.

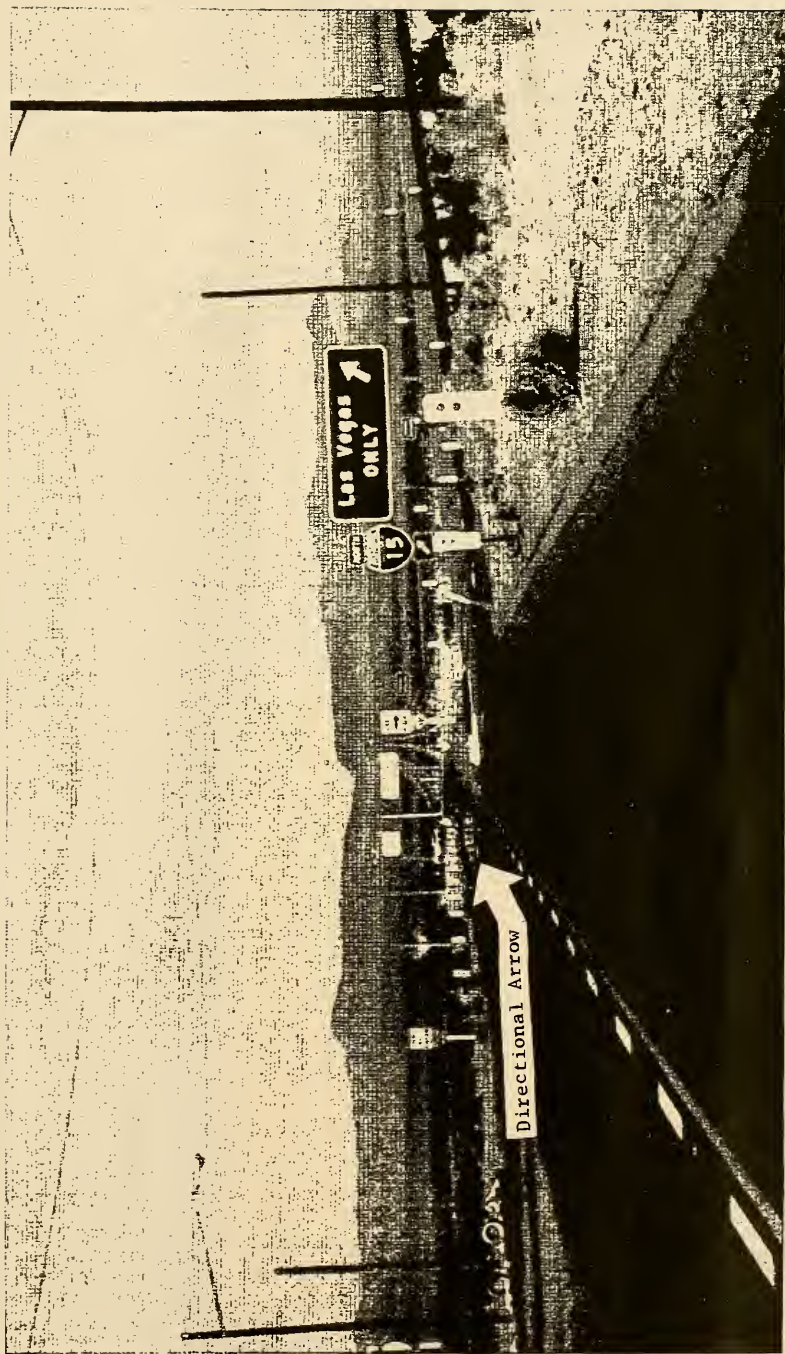
ILLUSTRATION 7

Baker interchange. Entrance to eastbound Interstate 15 (Las Vegas) is on right. Exit from westbound Interstate 15 to Baker is on left. Note Keep Right, Wrong-Way and Do Not Enter signs and centerline pavement markings. A white directional arrow is in place on the roadway pavement.
